DEPARTMENT OF TRANSPORTATION

Contract #: 04-0120F4Cty: SF/ALA Rte: 80 PM: 13.2/13.9File #: 69.28**WELDING INSPECTION REPORT****Resident Engineer:**Pursell, Gary**Address:** 333 Burma Road**City:** Oakland, CA 94607**Report No:** WIR-010277**Date Inspected:** 22-Oct-2009**Project Name:** SAS Superstructure**OSM Arrival Time:** 645**Prime Contractor:** American Bridge/Fluor Enterprises, a JV**OSM Departure Time:** 1845**Contractor:** Zhenhua Port Machinery Company, Ltd (ZPMC), Changxing Island **Location:** Shanghai, China**CWI Name:** Wang Chuan Qing.**CWI Present:** Yes No**Inspected CWI report:** Yes No N/A**Rod Oven in Use:** Yes No N/A**Electrode to specification:** Yes No N/A**Weld Procedures Followed:** Yes No N/A**Qualified Welders:** Yes No N/A**Verified Joint Fit-up:** Yes No N/A**Approved Drawings:** Yes No N/A**Approved WPS:** Yes No N/A**Delayed / Cancelled:** Yes No N/A**Bridge No:** 34-0006**Component:** Tower Components**Summary of Items Observed:**

WELDING INSPECTION REPORT

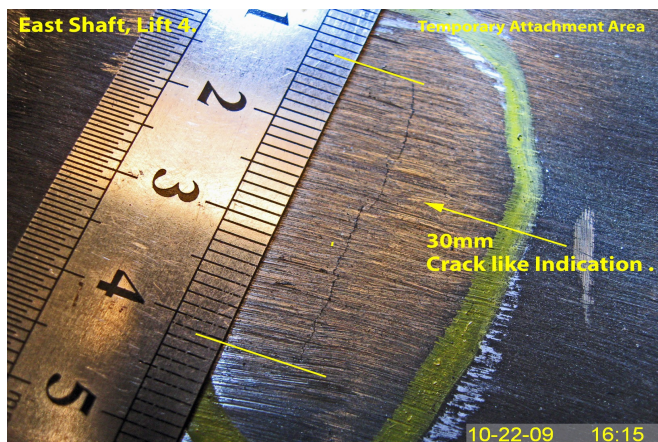
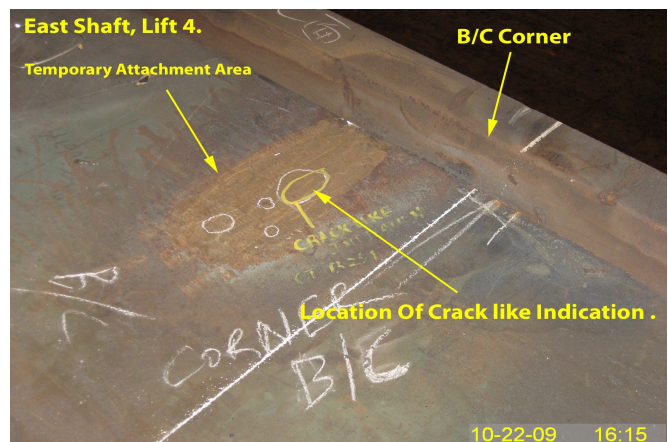
Bay 11, East Tower, Lift 4, B/C Corner.

During random visual inspection at East Tower, Lift 4(Temporary Attachment Area near Corner Seam B/C) this Caltrans Quality Assurance (QA) Inspector observed "Crack Like" indications at the removed Temporary attachment Weld area. The indications were shown to ZPMC and ABF QC Inspectors. No Incident Report has been written on this issue. The attached photographs provide additional detail. This QA Inspector carried out NDE on following
